**Flood Control Project Maintenance
Levee Inspections****LMA District Cover Sheet****Spring 2016 Levee Inspection Results****Sacramento River West Side Levee District**

Spring 2016 Levee Inspection Results

Sacramento River West Side Levee District

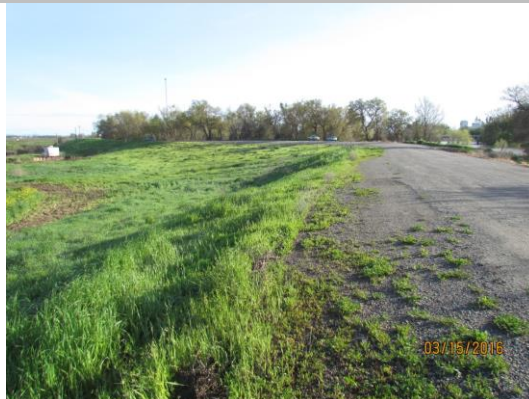
Photo 1 of 1 : SP_2016_NA0016_435_78_20160321_00191.jpg

LM Start	0.00	Rating **	M	Issue No.	78
LM End	0.92	Issue Type +	Ma	Location *	LS
Category	Earthen Levee			GPS Latitude/Longitude	
				Start	End
Item	Vegetation			38.799633 °	38.811874 °
				-121.725410 °	-121.724538 °
DWR ID	DWR_NA0016_01_f_2015_78				
Comment Code					
V1 : Control annual grass and weeds on the levee slopes and easements.					
Inspector Comment

View of the vegetation on the landward side of the levee looking upstream. Spring 2016.

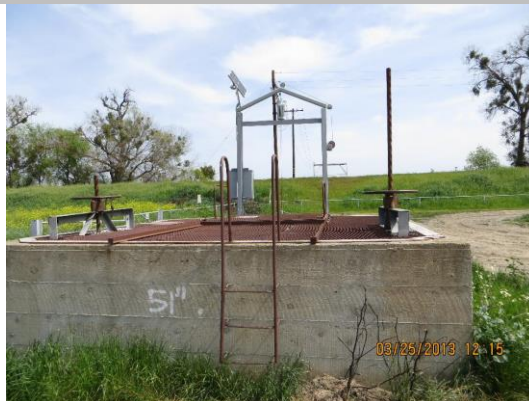
Photo 1 of 2 : UCIP_SP_2016_10103_17262.jpg

Comment Code					
Inspector Comment					
FS_ID:10103 DS_ID:20226 EP_NO: 1331 Repair Type: Non-Urgent Crossing Status: Found UCIP Comments: There is no gate in the slide gate at the concrete distribution box off the landside toe. This may not be an issue as there is a slide gate at the WS toe. FIELD_STRUCT_DESC: 54-inch corrugated metal irrigation pipe through levee 28.0 feet below crown. Vertical pumps on pile structure in the stream, walkway to pumps. Flap gates from pumps and slide gate inside a 7'X10-foot concrete surge box on the waterward side, 1948 installation. 15'X18-foot concrete distribution box 150-feet off landside toe with slide gate. (Permit No. 1331, 1948). Included in 1960 O&M manual. FS Date: 3/25/2013 7:36:51 AM

Concrete distribution box on 150-feet off landside toe.

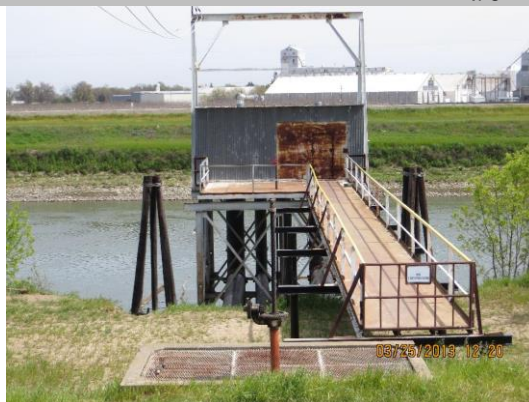
Photo 2 of 2 : UCIP_SP_2016_10103_17261.jpg

Pumping plant with concrete surge box and slide gate in foreground-off WS toe.

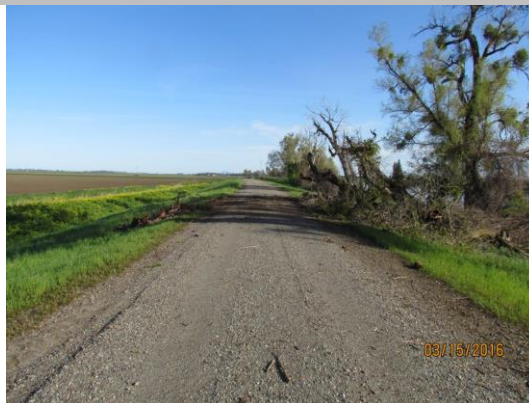
Photo 1 of 1 : SP_2016_NA0016_435_110_20160321_00194.jpg

LM Start	0.68	Rating **	M	Issue No.	110
LM End	0.68	Issue Type +	Ma	Location *	WS
Category	Earthen Levee			GPS Latitude/Longitude	
				Start	End
Item	Encroachments			38.808402 °	38.808402 °
				-121.724423 °	-121.724423 °
DWR ID	DWR_NA0016_01_s _ 2016_110				
Comment Code					
TR : Tree or limb					
Inspector Comment

View of the fallen tree on the waterward side of the levee looking upstream. Spring 2016.

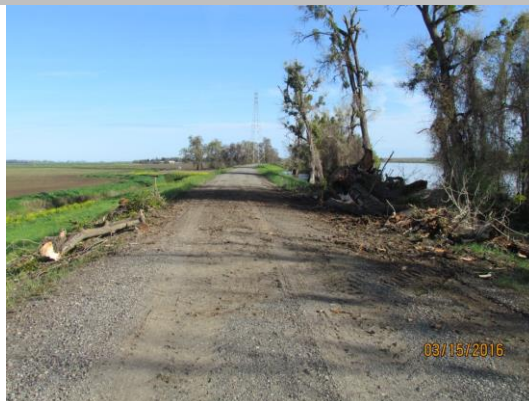
Photo 1 of 1 : SP_2016_NA0016_435_119_20160321_00196.jpg

LM Start	1.16	Rating **	M	Issue No.	119
LM End	1.16	Issue Type +	En	Location *	WS
Category	Earthen Levee			GPS Latitude/Longitude	
				Start	End
Item	Encroachments			38.815417 °	38.815417 °
				-121.725142 °	-121.725142 °
DWR ID	DWR_NA0016_01_s _ 2016_119				
Comment Code					
TR : Tree or limb					
Inspector Comment

View of the downed tree on the waterward side of the levee looking upstream. Spring 2016.

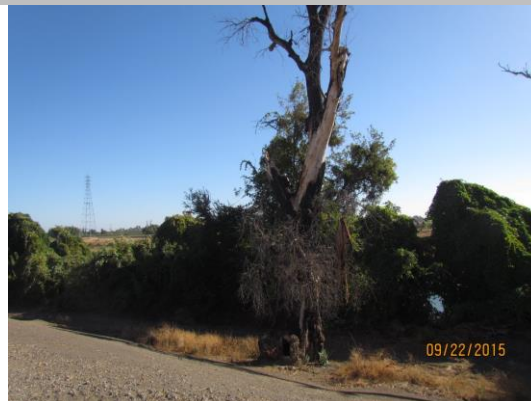
Photo 1 of 1 : SP_2016_NA0016_435_82_20160304_00036.jpg

LM Start	1.28	Rating **	A/W	Issue No.	82
LM End	1.28	Issue Type +	Ma	Location *	WS
Category	Earthen Levee			GPS Latitude/Longitude	
				Start	End
Item	Vegetation			38.817036 °	38.817036 °
				-121.725410 °	-121.725410 °
DWR ID	DWR_NA0016_01_s_2014_82				
Comment Code					
V7 : Trees / Woody Vegetation					
Inspector Comment

View of the dying tree on the waterward side of the levee. Monitor trees that could pose a threat to the integrity of the levee. Fall 2015.

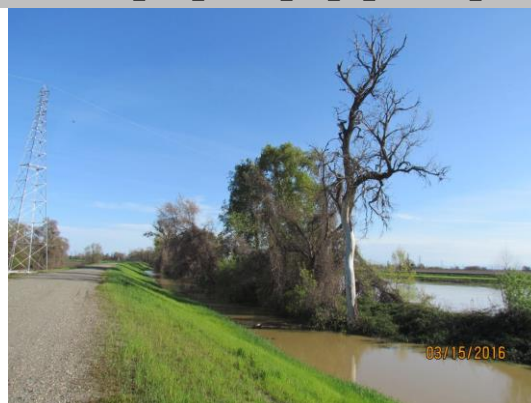
Photo 1 of 1 : SP_2016_NA0016_435_83_20160321_00197.jpg

LM Start	1.33	Rating **	A/W	Issue No.	83
LM End	1.33	Issue Type +	Ma	Location *	WS
Category	Earthen Levee			GPS Latitude/Longitude	
				Start	End
Item	Vegetation			38.817781 °	38.817781 °
				-121.725466 °	-121.725466 °
DWR ID	DWR_NA0016_01_s_2014_83				
Comment Code					
V7 : Trees / Woody Vegetation					
Inspector Comment					
Monitor trees that pose a future threat to the integrity of the levee

View of the tree on the waterward side of the levee looking upstream. Spring 2016.

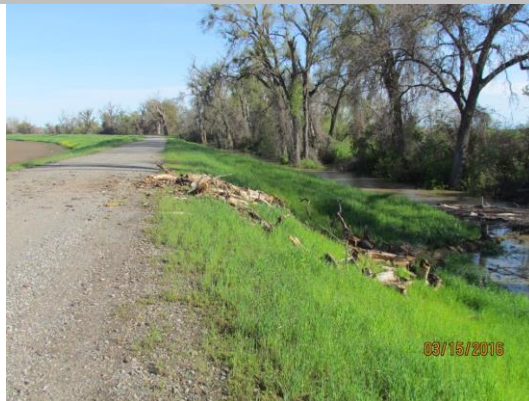
Photo 1 of 1 : SP_2016_NA0016_435_148_20160321_00199.jpg

LM Start	1.73	Rating **	M	Issue No.	148
LM End	1.73	Issue Type +	Ma	Location *	WS
Category	Earthen Levee			GPS Latitude/Longitude	
				Start	End
Item	Encroachments			38.823501 °	38.823501 °
				-121.724630 °	-121.724630 °
DWR ID	DWR_NA0016_01_s_2016_148				
Comment Code					
TR : Tree or limb					
Inspector Comment

Fallen tree is on the waterward slope of the levee looking upstream.
Spring 2016.

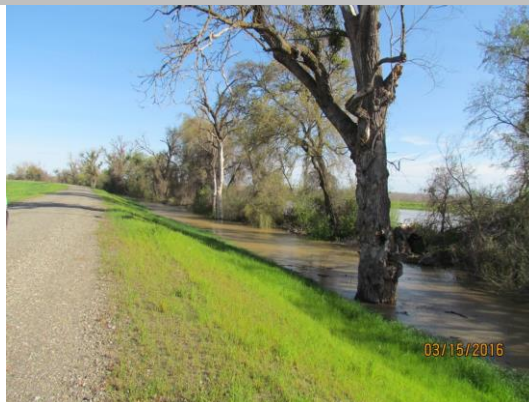
Photo 1 of 1 : SP_2016_NA0016_435_84_20160321_00200.jpg

LM Start	1.87	Rating **	A/W	Issue No.	84
LM End	1.87	Issue Type +	Ma	Location *	WS
Category	Earthen Levee			GPS Latitude/Longitude	
				Start	End
Item	Vegetation			38.825534 °	38.825534 °
				-121.724749 °	-121.724749 °
DWR ID	DWR_NA0016_01_s_2014_84				
Comment Code					
V7 : Trees / Woody Vegetation					
Inspector Comment					
Monitor trees that pose a future threat to the integrity of the levee.

View of the tree on the waterward side of the levee looking upstream.
Spring 2016.

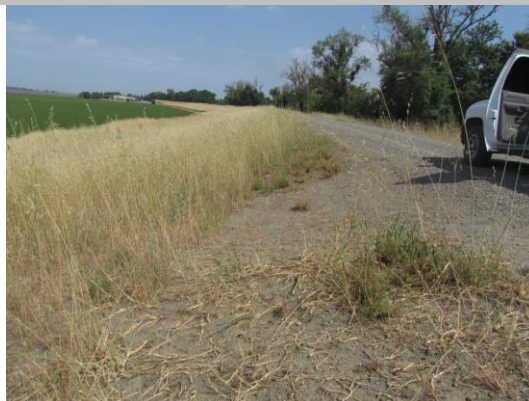
Photo 1 of 1 : SP_2016_NA0016_435_85_20160304_00039.jpg

LM Start	1.94	Rating **	A/W	Issue No.	85
LM End	1.94	Issue Type +	Ma	Location *	LS
Category	Earthen Levee			GPS Latitude/Longitude	
				Start	End
Item	Slope Stability			38.826567 °	38.826567 °
				-121.725060 °	-121.725060 °
DWR ID	DWR_NA0016_01_s _ 2015_85				
Comment Code					
S1 : Repair slope instability.					
Inspector Comment					
This issue should be monitored.

View of the sloughing on the landward side of the levee looking upstream. Spring 2015.

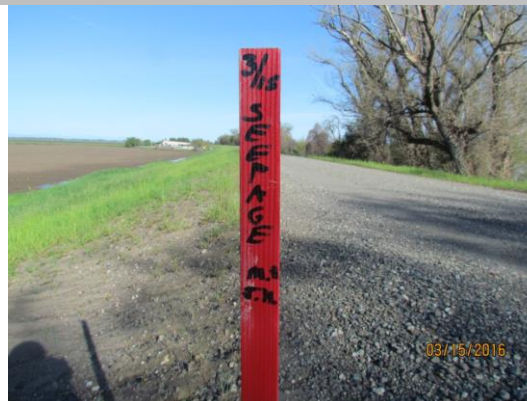
Photo 1 of 2 : SP_2016_NA0016_435_149_20160321_00201.jpg

LM Start	2.17	Rating **	U	Issue No.	149
LM End	2.38	Issue Type +	Ob	Location *	LS
Category	Earthen Levee			GPS Latitude/Longitude	
				Start	End
Item	Seepage / Sandboils			38.829567 °	38.832050 °
				-121.726814 °	-121.729140 °
DWR ID	DWR_NA0016_01_s_2016_149				
Comment Code					
Inspector Comment					
Seepage area has been staked and noted by LMA. Monitor seepage site.

The monitoring stake is on the shoulder of the levee on the landward side. Spring 2016.

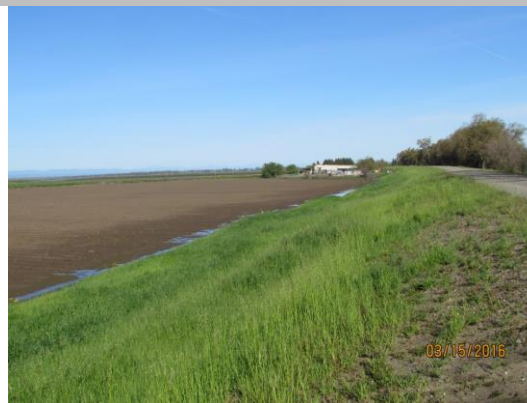
Photo 2 of 2 : SP_2016_NA0016_435_149_20160321_00202.jpg

View of the seepage on the landward side of the levee looking upstream. Spring 2016.

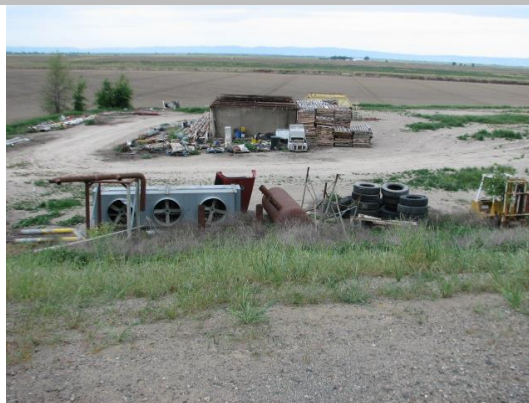
Photo 1 of 2 : SP_2016_NA0016_435_1550_20160304_00082.jpg

Pieces of machinery and debris at the levee toe. Spring 2014

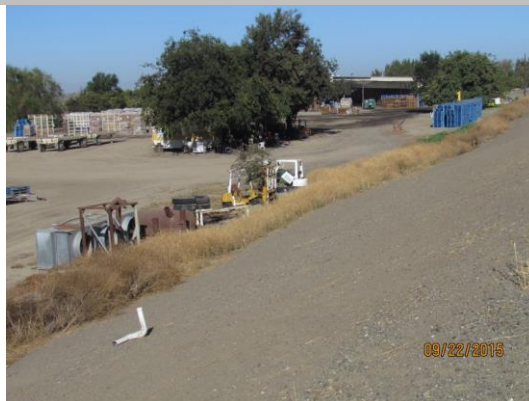
Photo 2 of 2 : SP_2016_NA0016_435_1550_20160304_00083.jpg

View of the machinery along the landward levee toe looking upstream.
Fall 2015.

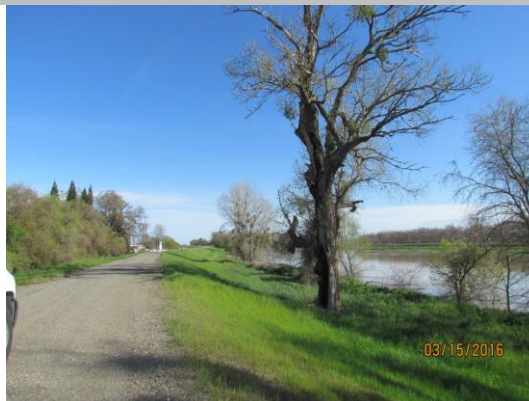
Photo 1 of 1 : SP_2016_NA0016_435_150_20160321_00203.jpg

LM Start	2.70	Rating **	A/W	Issue No.	150
LM End	2.70	Issue Type +	Ma	Location *	WS
Category	Earthen Levee			GPS Latitude/Longitude	
				Start	End
Item	Vegetation			38.835831 °	38.835831 °
				-121.732077 °	-121.732077 °
DWR ID	DWR_NA0016_01_s_2016_150				
Comment Code					
V7 : Trees / Woody Vegetation					
Inspector Comment					
Monitor trees that pose a future threat to the integrity of the levee.

View of the tree on the waterward side of the levee looking upstream. Spring 2016.

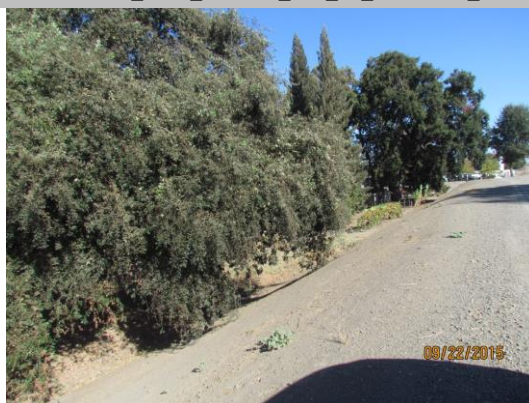
Photo 1 of 1 : SP_2016_NA0016_435_98_20160304_00050.jpg

LM Start	2.74	Rating **	M	Issue No.	98
LM End	2.74	Issue Type +	Ma	Location *	LS
Category	Earthen Levee			GPS Latitude/Longitude	
				Start	End
Item	Trim / Thin Trees			38.836454 °	38.836454 °
				-121.732037 °	-121.732037 °
DWR ID	DWR_NA0016_01_f_2015_98				
Comment Code					
T1 : Trim trees to at least five feet above ground level.					
Inspector Comment

View of the trees on the landward side of the levee that needs to be trimmed looking upstream. Fall 2015.

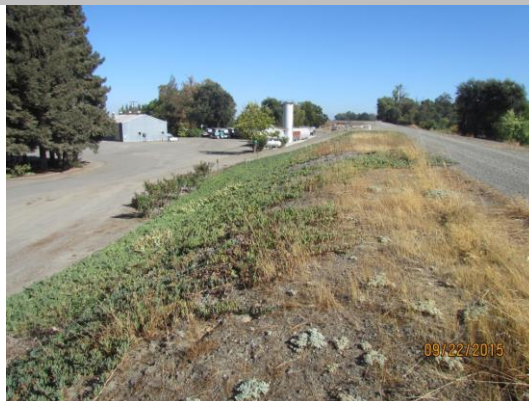
Photo 1 of 1 : SP_2016_NA0016_435_6_20160304_00006.jpg

LM Start	2.80	Rating **	M	Issue No.	6
LM End	2.80	Issue Type +	En	Location *	LS
Category	Earthen Levee			GPS Latitude/Longitude	
				Start	End
Item	Vegetation			38.837300 °	38.837300 °
				-121.731775 °	-121.731775 °
DWR ID	DWR_NA0016_01_f_2012_6				
Comment Code					
V6 : Landscaping					
Inspector Comment					
River Garden Farms

View of the landscaping along the landward slope at River Gardens Farms looking upstream. Fall 2015.

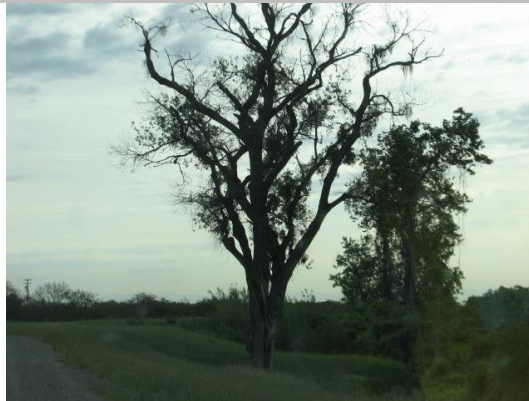
Photo 1 of 1 : SP_2016_NA0016_435_86_20160304_00040.jpg

LM Start	3.14	Rating **	A/W	Issue No.	86
LM End	3.14	Issue Type +	Ma	Location *	WS
Category	Earthen Levee			GPS Latitude/Longitude	
				Start	End
Item	Vegetation			38.841283 °	38.841283 °
				-121.728827 °	-121.728827 °
DWR ID	DWR_NA0016_01_s _ 2014_86				
Comment Code					
V7 : Trees / Woody Vegetation					
Inspector Comment

Monitor trees that pose a future threat to the integrity of the levee.
Spring 2014

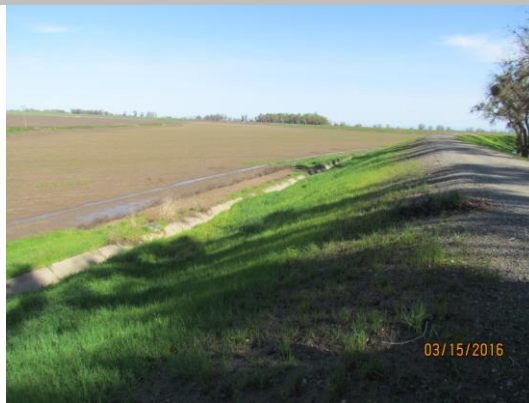
Photo 1 of 1 : SP_2016_NA0016_435_8_20160321_00204.jpg

LM Start	3.56	Rating **	M	Issue No.	8
LM End	3.94	Issue Type +	En	Location *	LS
Category	Earthen Levee			GPS Latitude/Longitude	
				Start	End
Item	Encroachments			38.846785 °	38.850758 °
				-121.729995 °	-121.725263 °
DWR ID	DWR_NA0016_01_s _ 2012_8				
Comment Code					
DT : Ditch					
Inspector Comment					
Concrete lined ditch runs along the levee toe.

View of the ditch on the landward side of the levee looking upstream.
Spring 2016.

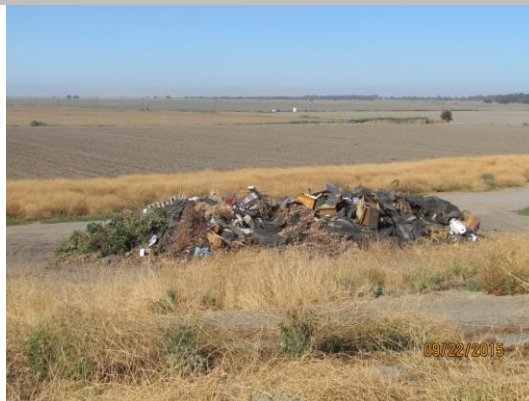
Photo 1 of 2 : SP_2016_NA0016_435_1551_20160304_00085.jpg

LM Start	4.59	Rating **	M	Issue No.	1551
LM End	4.59	Issue Type +	En	Location *	LS
Category	Earthen Levee			GPS Latitude/Longitude	
				Start	End
Item	Encroachments			38.856995 °	38.856995 °
				-121.730938 °	-121.730938 °
DWR ID	DWR_NA0016_01_f_2013_1551				
Comment Code					
DE : Debris					
Inspector Comment					
Previous pile has been burned but a new pile has started at the same spot.

View of the ongoing debris pile at the landward levee toe. Fall 2015.

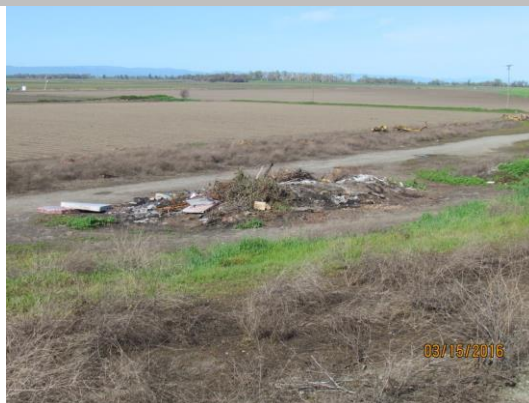
Photo 2 of 2 : SP_2016_NA0016_435_1551_20160321_00207.jpg

View of the debris pile on landward levee toe. Spring 2016.

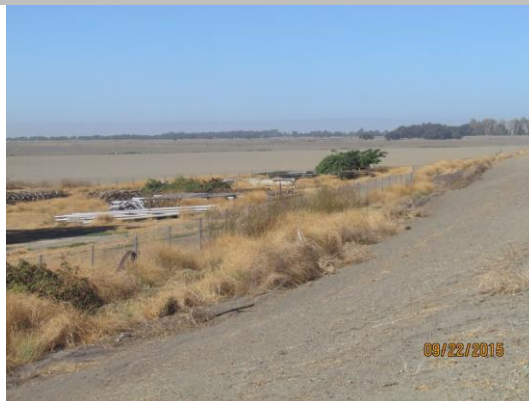
Photo 1 of 1 : SP_2016_NA0016_435_9_20160304_00009.jpg

LM Start	4.80	Rating **	M	Issue No.	9
LM End	4.80	Issue Type +	En	Location *	LS
Category	Earthen Levee			GPS Latitude/Longitude	
				Start	End
Item	Encroachments			38.859446 °	38.859446 °
				-121.732774 °	-121.732774 °
DWR ID	DWR_NA0016_01_s _ 2012_9				
Comment Code					
FE : Fence					
Inspector Comment					
chain link fence runs along levee

View of the chain link fence along the landward levee toe looking upstream. The fence does not obstruct the view. Fall 2015.

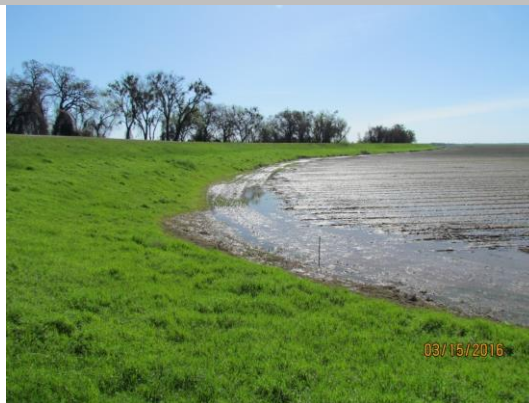
Photo 2 of 3 : SP_2016_NA0016_435_152_20160321_00212.jpg

LM Start	6.12	Rating **	U	Issue No.	152
LM End	6.12	Issue Type +	Ob	Location *	LS
Category	Earthen Levee			GPS Latitude/Longitude	
				Start	End
Item	Seepage / Sandboils			38.870503 °	38.870503 °
				-121.750068 °	-121.750068 °
DWR ID	DWR_NA0016_01_s_2016_152				
Comment Code					
Inspector Comment					
Seepage area has been staked and noted by LMA. Monitor seepage site.

View of the seepage on the landward side of the levee looking downstream. Spring 2016.

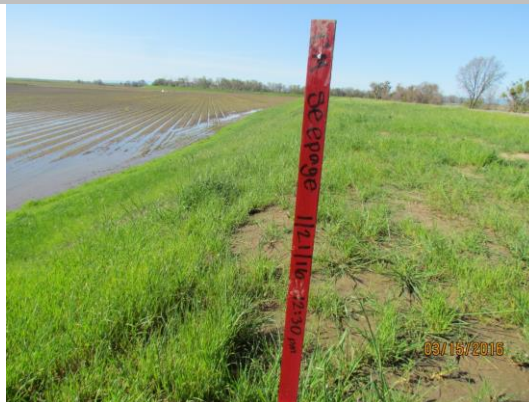
Photo 3 of 3 : SP_2016_NA0016_435_152_20160321_00211.jpg

LMA monitoring stake for the seepage. Spring 2016.

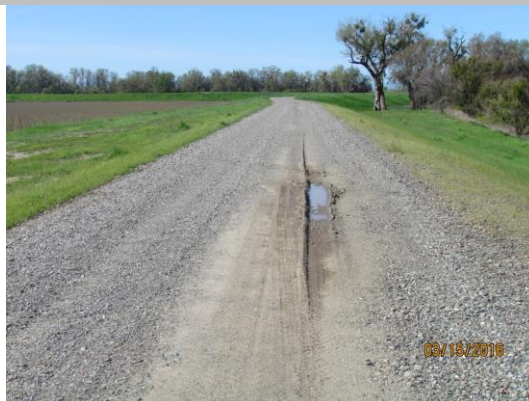
Photo 1 of 1 : SP_2016_NA0016_435_154_20160321_00213.jpg

LM Start	6.31	Rating **	M	Issue No.	154
LM End	6.31	Issue Type +	Ma	Location *	CR
Category	Earthen Levee			GPS Latitude/Longitude	
				Start	End
Item	Crown Surface / Depressions / Rutting			38.869088 °	38.869088 °
				-121.753220 °	-121.753220 °
DWR ID	DWR_NA0016_01_s _ 2016_154				
Comment Code					
C2 : Repair depressions or ruts in the crown or slope.					
Inspector Comment

View of the rut on the crown of the levee looking upstream. Spring 2016.

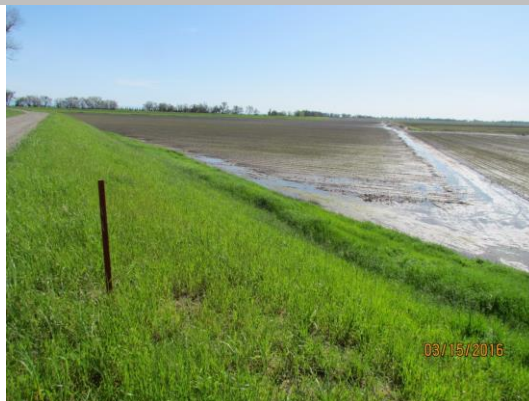
Photo 1 of 2 : SP_2016_NA0016_435_156_20160321_00214.jpg

LM Start	6.50	Rating **	U	Issue No.	156
LM End	6.62	Issue Type +	Ob	Location *	LS
Category	Earthen Levee			GPS Latitude/Longitude	
				Start	End
Item	Seepage / Sandboils			38.868127°	38.867530°
				-121.756499°	-121.758427°
DWR ID	DWR_NA0016_01_s _ 2016_156				
Comment Code					
Inspector Comment					
Seepage area has been staked and noted by LMA. Monitor seepage site.

View of the seepage on the landward side of the levee looking downstream. Spring 2016.

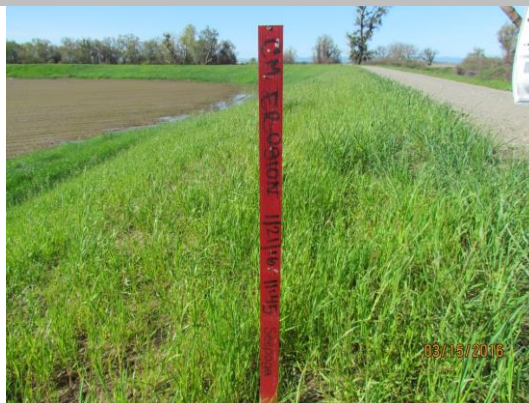
Photo 2 of 2 : SP_2016_NA0016_435_156_20160321_00215.jpg

Stake marks the seepage site on the levee prism and is placed on the landward shoulder. Spring 2016.

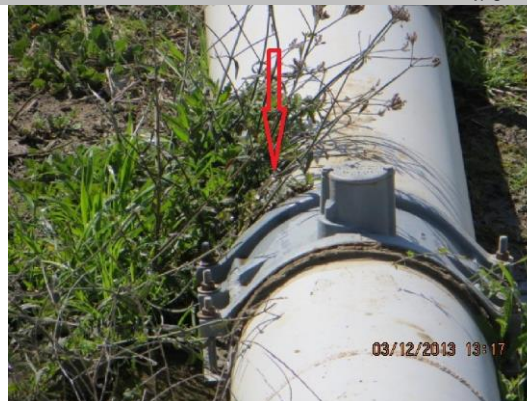
Photo 1 of 2 : UCIP_SP_2016_10129_17291.jpg

LM Start	6.82	Rating **	M	Issue No.	1581
LM End	6.82	Issue Type +	En	Location *	WS
Category	Supplemental	GPS Latitude/Longitude			
		Start		End	
Item	DWR UCIP Field Study	38.864862 °		38.864862 °	
		-121.757516 °		-121.757516 °	
DWR ID					
Comment Code					
Inspector Comment					
FS_ID:10129 DS_ID:20228 EP_NO: 1297 Repair Type: Non-Urgent Crossing Status: Found UCIP Comments: Leak at flowmeter on WS berm may become problem in near future. FIELD_STRUCT_DESC: *REMOVED*2 of 2: 16-inch steel pipe through levee 5.2 feet below crown. Slant pumps in metal pump house on the waterward bank, supported on steel structure. Pipes discharge into 9.5'x12' concrete distribution box on the landward side. Sparline flow meter on pipes near the waterward toe. (Permit No. 1297, 1948). Also included in the 1960 O&M manual. Removed under permit No. 8501, 2012. FS Date: 3/12/2013

Minor leak at flowmeter on WS berm.

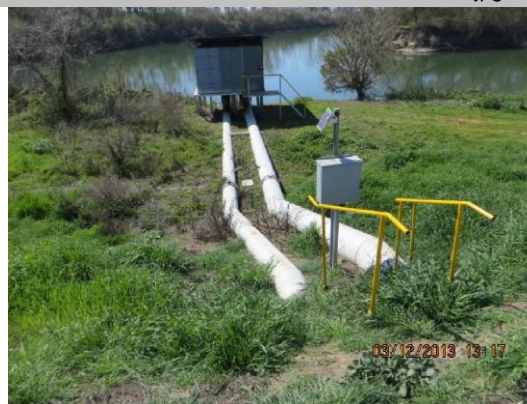
Photo 2 of 2 : UCIP_SP_2016_10129_17290.jpg

Pumphouse and steps on WS.

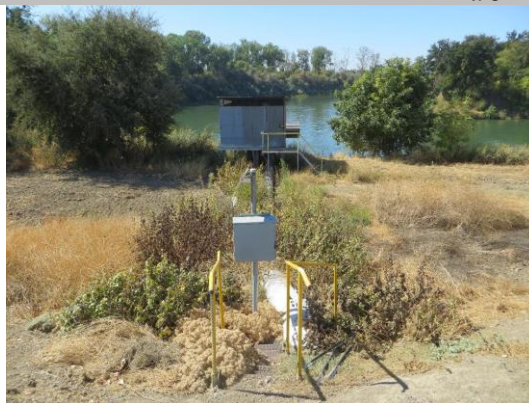
Photo 1 of 2 : UCIP_SP_2016_46765_74700.jpg

FS_ID:46765
DS_ID:25125
EP_NO: 8501
Repair Type: Non-Urgent
Crossing Status: Found
UCIP Comments: field inspection of the site revealed a few minor actions: 1. there are metal fence posts located near the pipe that should be cleared out for safety, 2. vegetation around the pipes should be cleared as it limits inspection, 3. some burrowing activity was noticed nearby the pipes.
FIELD_STRUCT_DESC: A 20 inch steel pipe and a 16 inch steel pipe are located at levee mile 6.889 and 6.89, respectively. Both pipes have a protective paint coating. The pipes are used to supply irrigation water to the adjacent fields. On the water side of the levee, the pipes are above ground and follow the slope of the bank into the river. A metal pumphouse, supported on a steel frame is located on a bench on the waterside of the levee. When the pumps are operational a drum fish screen is lowered over the pipe intakes on a track. Both irrigation pipes travel through the levee and have siphon breakers in CMP risers on the land side crest of the levee. The pipes discharge under submerged conditions to a 9.5 ft x 12 ft concrete distribution box. There are two gated outlets on the distribution box that lead to distribution canals. FS Date: 10/9/2015 9:00:32 AM

view from levee crest along pipe profile on water side of levee. pipe daylight from levee and pumphouse.

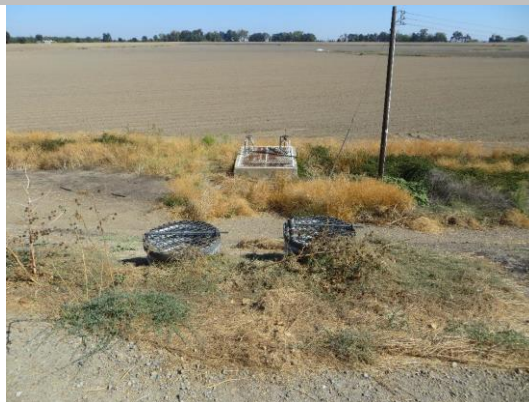
Photo 2 of 2 : UCIP_SP_2016_46765_74701.jpg

view from levee crest along pipe profile toward land side of levee. CMP risers with siphon breakers and distribution box near land side levee toe.

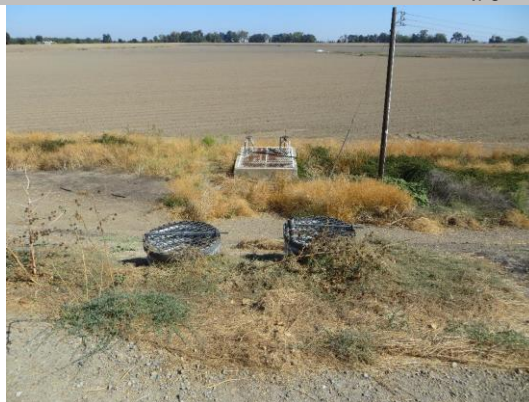
Photo 2 of 2 : UCIP_SP_2016_46766_74706.jpg

FS_ID:46766
DS_ID:25126
EP_NO: 8501
Repair Type: Non-Urgent
Crossing Status: Found
UCIP Comments: a few actions are recommended based on field inspection: 1. clear out metal fence posts near daylight of pipe on water side levee. 2. clear vegetation around pipes on water side of levee to aid in inspection. 3. monitor burrowing activities on water side of levee. FIELD_STRUCT_DESC: A 20 inch steel pipe and a 16 inch steel pipe are located at levee mile 6.889 and 6.89, respectively. Both pipes have a protective paint coating. The pipes are used to supply irrigation water to the adjacent fields. On the water side of the levee, the pipes are above ground and follow the slope of the bank into the river. A metal pumphouse, supported on a steel frame is located on a bench on the waterside of the levee. When the pumps are operational a drum fish screen is lowered over the pipe intakes on a track. Both irrigation pipes travel through the levee and have siphon breakers in CMP risers on the land side crest of the levee. The pipes discharge under submerged conditions to a 9.5 ft x 12 ft concrete distribution box. There are two gated outlets on the distribution box that lead to distribution canals. FS Date: 10/9/2015

view from levee crest along pipe looking towards land side. shows siphon breaker standpipes and distribution box.

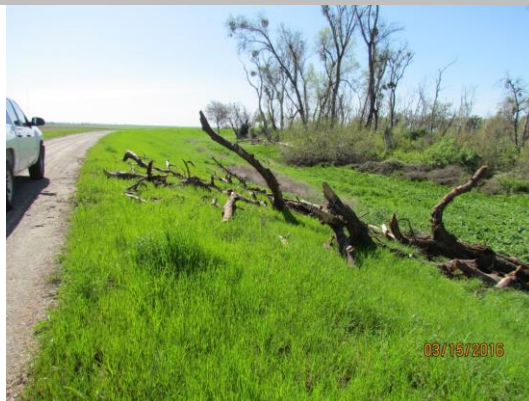
Photo 1 of 1 : SP_2016_NA0016_435_157_20160321_00216.jpg

LM Start	6.87	Rating **	M	Issue No.	157							
LM End	6.87	Issue Type +	Ma	Location *	WS							
Category	Earthen Levee		GPS Latitude/Longitude									
			Start	End								
Item	Encroachments		38.864225 °	38.864225 °								
			-121.757024 °	-121.757024 °								
DWR ID	DWR_NA0016_01_s _ 2016_157											
Comment Code												
TR : Tree or limb												
Inspector Comment

View of the tree on the waterward side of the levee looking upstream.
Spring 2016.

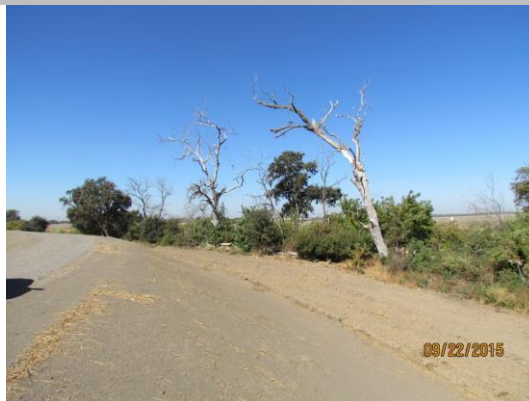
Photo 1 of 1 : SP_2016_NA0016_435_114_20160304_00060.jpg

LM Start	7.57	Rating **	A/W	Issue No.	114
LM End	7.57	Issue Type +	Ma	Location *	WS
Category	Earthen Levee			GPS Latitude/Longitude	
				Start	End
Item	Vegetation			38.863323 °	38.863323 °
				-121.765177 °	-121.765177 °
DWR ID	DWR_NA0016_01_f_2015_114				
Comment Code					
V7 : Trees / Woody Vegetation					
Inspector Comment

View of the dying tree on the waterward side of the levee looking upstream. Fall 2015.

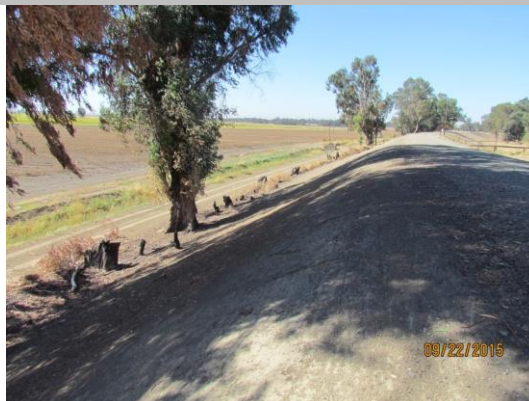
Photo 1 of 1 : SP_2016_NA0016_435_116_20160304_00062.jpg

LM Start	7.80	Rating **	N	Issue No.	116
LM End	8.64	Issue Type +	Ma	Location *	LS
Category	Earthen Levee			GPS Latitude/Longitude	
				Start	End
Item	Trim / Thin Trees			38.861357 °	38.856379 °
				-121.768641 °	-121.781943 °
DWR ID	DWR_NA0016_01_f_2015_116				
Comment Code					
T5 : Tree stumps.					
Inspector Comment

View of the tree stumps along the landward levee toe looking upstream. Fall 2015.

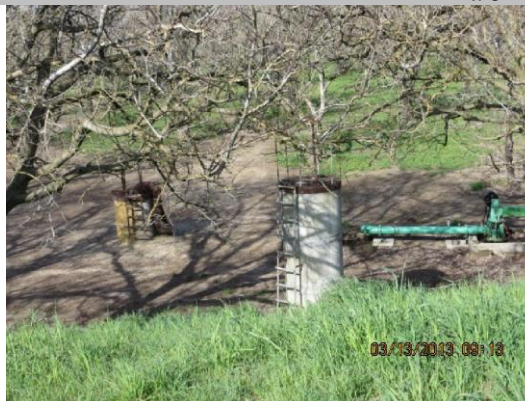
Photo 1 of 2 : UCIP_SP_2016_10150_17328.jpg

LM Start	9.21	Rating **	U	Issue No.	1584
LM End	9.21	Issue Type +	En	Location *	LS
Category	Supplemental			GPS Latitude/Longitude	
				Start	End
Item	DWR UCIP Field Study			38.860993 °	38.860993 °
				-121.784840 °	-121.784840 °
DWR ID					
Comment Code					
Inspector Comment					
FS_ID:10150 DS_ID:20231 EP_NO: 1641 Repair Type: Urgent Crossing Status: Found UCIP Comments: Meter removed from pipe on WS and pipe open. Appears abandoned. Pipe should be abandoned properly. FIELD_STRUCT_DESC: 14-inch steel pipe through levee 5.2 feet below crown. Pump on concrete pump platform on the bank. Siphon breaker on the landward slope. Sparling flow meter on pipe on the waterward slope. 42 inch concrete standpipe in concrete distribution box at the landward toe. (Permit No. 1641, 1959). Included in the 1960 O&M Manual. FS Date: 3/13/2013

Concrete riser on LS toe.

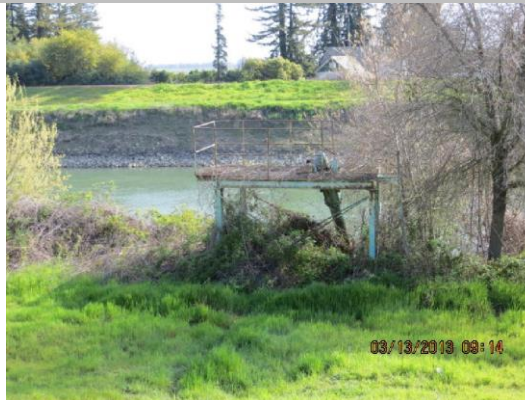
Photo 2 of 2 : UCIP_SP_2016_10150_17327.jpg

Pump platform on WS.

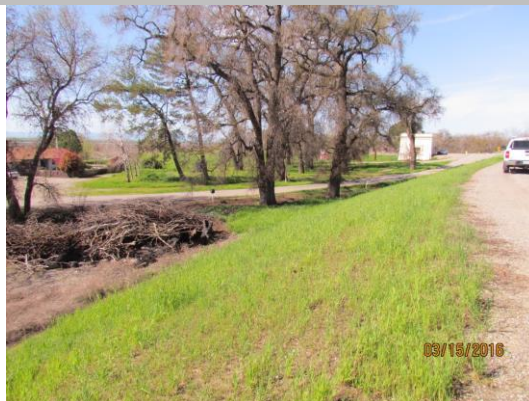
Photo 1 of 1 : SP_2016_NA0016_435_160_20160321_00218.jpg

LM Start	9.67	Rating **	M	Issue No.	160
LM End	9.67	Issue Type +	En	Location *	LS
Category	Earthen Levee			GPS Latitude/Longitude	
				Start	End
Item	Encroachments			38.862279 °	38.862279 °
				-121.791088 °	-121.791088 °
DWR ID	DWR_NA0016_01_s_2016_160				
Comment Code					
PR : Prunings					
Inspector Comment

View of the pruning pile on the landward side of the levee looking upstream. Spring 2016.

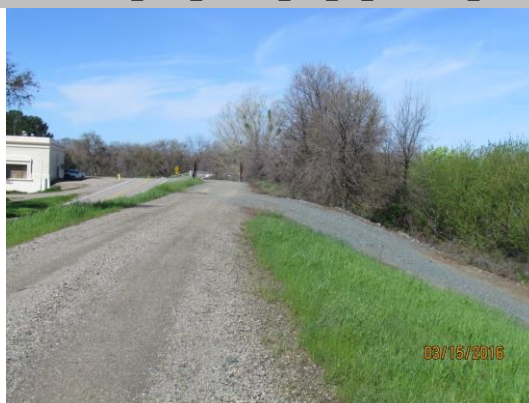
Photo 1 of 2 : SP_2016_NA0016_435_29_20160321_00220.jpg

LM Start	9.68	Rating **	A/W	Issue No.	29
LM End	9.79	Issue Type +	Ma	Location *	WS
Category	Earthen Levee			GPS Latitude/Longitude	
				Start	End
Item	Vegetation			38.862345 °	38.862848 °
				-121.791337 °	-121.793267 °
DWR ID	DWR_NA0016_01_s_2012_29				
Comment Code					
V8 : Environmental Requirements.					
Inspector Comment

View of the revegetation site on the waterward side of the levee looking upstream. Spring 2016.

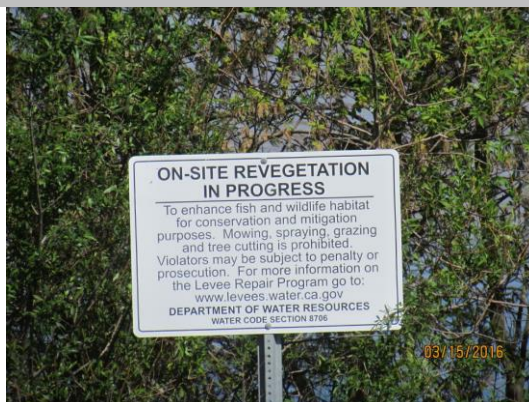
Photo 2 of 2 : SP_2016_NA0016_435_29_20160321_00219.jpg

Revegetation site sign. Spring 2016.

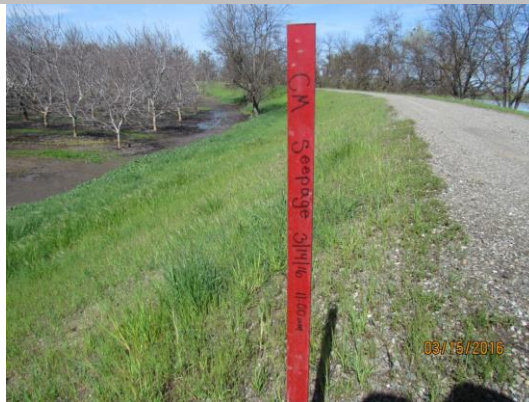
Photo 2 of 2 : SP_2016_NA0016_435_161_20160321_00221.jpg

LM Start	9.95	Rating **	U	Issue No.	161
LM End	10.04	Issue Type +	Ob	Location *	LS
Category	Earthen Levee			GPS Latitude/Longitude	
				Start	End
Item	Seepage / Sandboils			38.864759 °	38.865583 °
				-121.794563 °	-121.795685 °
DWR ID	DWR_NA0016_01_s_2016_161				
Comment Code					
Inspector Comment					
Seepage area has been staked and noted by LMA. Monitor seepage site.

Stake shows LMA is monitoring the seepage. Spring 2016.

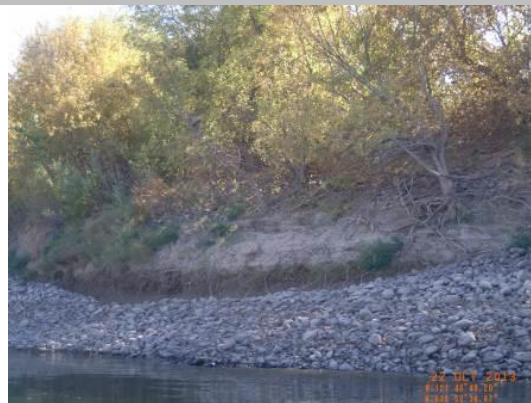
Photo 1 of 1 : SP_2016_NA0016_435_7_20160304_00007.jpg

LM Start	11.50	Rating **	M	Issue No.	7
LM End	11.53	Issue Type +	Ma	Location *	WS
Category	Supplemental			GPS Latitude/Longitude	
				Start	End
Item	2015 USACE Erosion Survey, DRAFT			38.874854 °	38.875109 °
				-121.813018 °	-121.813592 °
DWR ID	DWR_NA0016_01_s_2016_7				
Comment Code					
Inspector Comment					
1997 - Toe damage and loss of cobble revetment and small patch of local damage to the cobble revetment. 2000 - Cohesive vertical toe; revegetation site. 2015: No observed changes. [2015 Site ID: SAC_101-3_R]

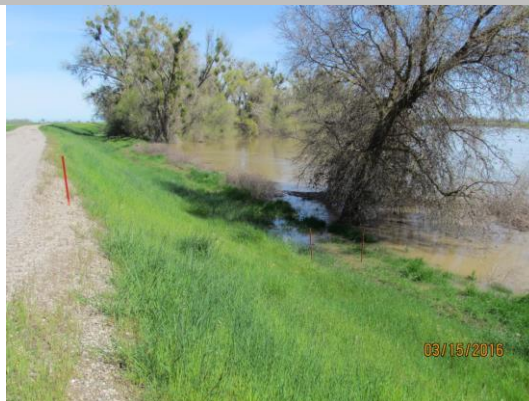
Photo 1 of 2 : SP_2016_NA0016_435_164_20160321_00229.jpg

LM Start	12.28	Rating **	M	Issue No.	164
LM End	12.28	Issue Type +	Ma	Location *	LS
Category	Earthen Levee			GPS Latitude/Longitude	
				Start	End
Item	Erosion / Bank Caving			38.884466 °	38.884466 °
				-121.817178 °	-121.817178 °
DWR ID	DWR_NA0016_01_s _ 2016_164				
Comment Code					
E1 : Note and monitor erosion site.					
Inspector Comment					
LMA is monitoring erosion site with stakes.

View of the erosion staked by the LMA on the waterward side of the levee looking upstream. Spring 2016.

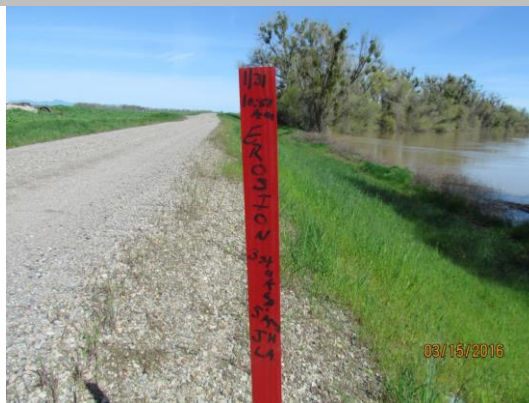
Photo 2 of 2 : SP_2016_NA0016_435_164_20160321_00227.jpg

Stake marking the erosion site. Spring 2016.

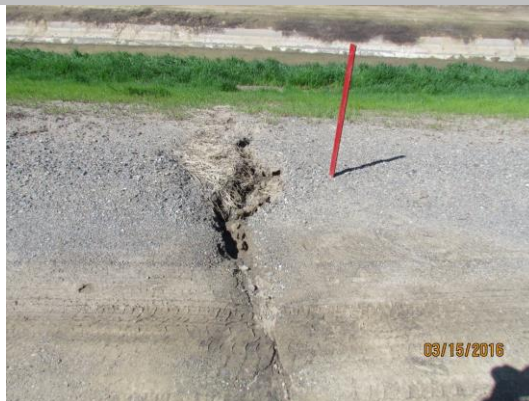
Photo 2 of 2 : SP_2016_NA0016_435_166_20160322_00234.jpg

LM Start	13.39	Rating **	M	Issue No.	166 (cont)	
LM End	13.39	Issue Type +	Ma	Location *	LS	
Category	Earthen Levee			GPS Latitude/Longitude		
				Start		End
Item	Erosion / Bank Caving			38.896833 °	38.896833 °	
				-121.804512 °	-121.804512 °	
DWR ID	DWR_NA0016_01_s_2016_166					
Comment Code						
E1 : Note and monitor erosion site.						
Inspector Comment						
Runoff erosion is being monitored. Erosion is about 8 inches deep, 16 inches wide and 3 feet in length.

Erosion is caused by runoffs. Spring 2016.

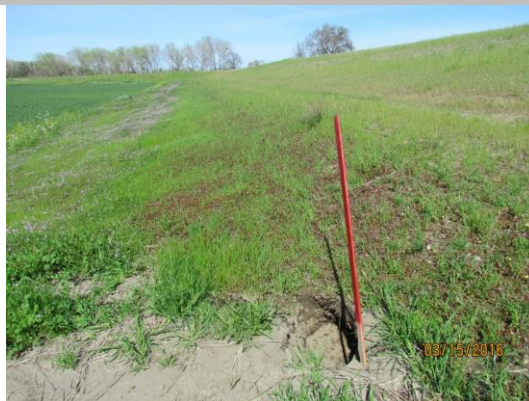
Photo 1 of 2 : SP_2016_NA0016_435_167_20160322_00237.jpg

LM Start	13.98	Rating **	U	Issue No.	167
LM End	13.98	Issue Type +	Ma	Location *	LS
Category	Earthen Levee			GPS Latitude/Longitude	
				Start	End
Item	Animal Control			38.904886 °	38.904886 °
				-121.806490 °	-121.806490 °
DWR ID	DWR_NA0016_01_s _ 2016_167				
Comment Code					
A2 : Repair the levee slope damaged by livestock and prevent large animal access.					
Inspector Comment					
Foxhole is close to the levee toe.

Perspective view of the fox hole on the landward side of the levee looking upstream. Spring 2016.

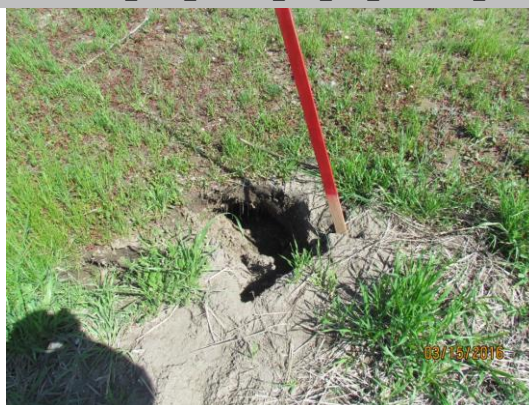
Photo 2 of 2 : SP_2016_NA0016_435_167_20160322_00235.jpg

Fox hole is close to the toe of the levee. Spring 2016.

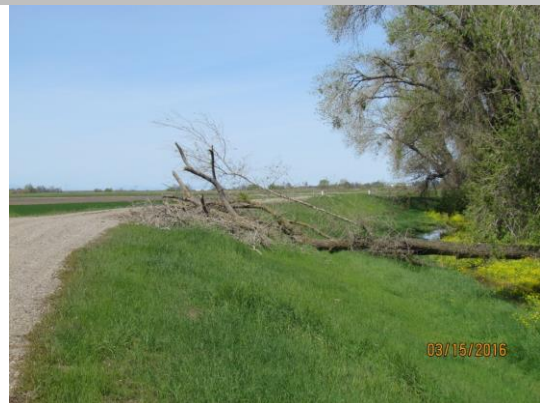
Photo 1 of 1 : SP_2016_NA0016_435_170_20160322_00238.jpg

LM Start	14.66	Rating **	M	Issue No.	170
LM End	14.66	Issue Type +	Ma	Location *	WS
Category	Earthen Levee			GPS Latitude/Longitude	
				Start	End
Item	Encroachments			38.910751 °	38.910751 °
				-121.816017 °	-121.816017 °
DWR ID	DWR_NA0016_01_s _ 2016_170				
Comment Code					
TR : Tree or limb					
Inspector Comment

View of the fallen tree on the waterward side of the levee looking upstream. Spring 2016.

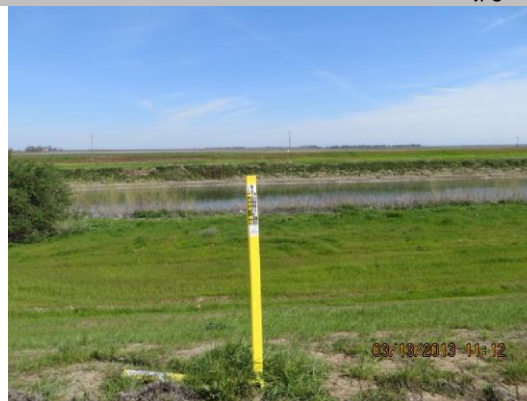
Photo 1 of 2 : UCIP_SP_2016_10203_17399.jpg

LM Start	16.22	Rating **	M	Issue No.	1562
LM End	16.22	Issue Type +	En	Location *	CR
Category	Supplemental			GPS Latitude/Longitude	
				Start	End
Item	DWR UCIP Field Study			38.923407 °	38.923407 °
				-121.834588 °	-121.834588 °
DWR ID					
Comment Code					
Inspector Comment					
FS_ID:10203 DS_ID:20432 EP_NO: N/A Repair Type: Non-Urgent Crossing Status: Found UCIP Comments: Need to determine if this is a permitted crossing as it was not previously noted. Need to determine size and depth below the crown. FIELD_STRUCT_DESC: Gas line through levee at unknown depth below the crown. Marker on WS shoulder. FS Date: 3/13/2013

Gasline marker on WS shoulder.

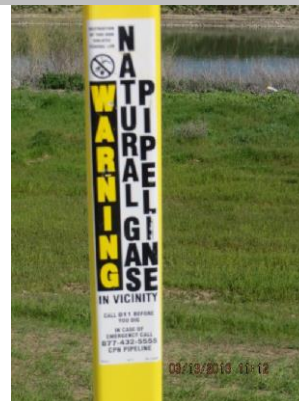
Photo 2 of 2 : UCIP_SP_2016_10203_17398.jpg

Gasline marker on WS shoulder.

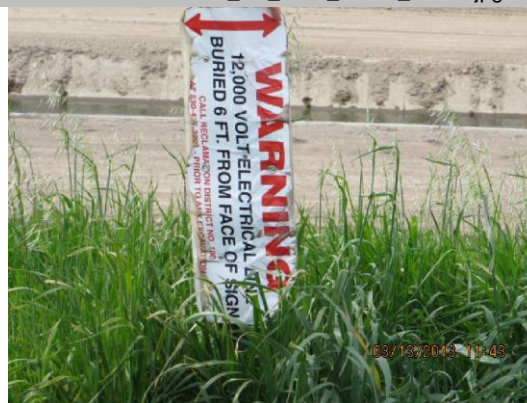
Photo 1 of 1 : UCIP_SP_2016_11323_18720.jpg

LM Start	17.94	Rating **	M	Issue No.	1554
LM End	17.94	Issue Type +	En	Location *	LS
Category	Supplemental			GPS Latitude/Longitude	
				Start	End
Item	DWR UCIP Field Study			38.942979 °	38.942979 °
				-121.837030 °	-121.837030 °
DWR ID					
Comment Code					
Inspector Comment					
FS_ID:11323 DS_ID:22957 EP_NO: 18026 Repair Type: Non-Urgent Crossing Status: Found UCIP Comments: Conduit needs to be located and signs installed where it crosses the levee crown. FIELD_STRUCT_DESC: Electric Conduit through the levee at unknown depth. Signage on LS shoulder. (Permit No. 18026, 2007) FS Date: 3/13/2013

Sign on LS shoulder.

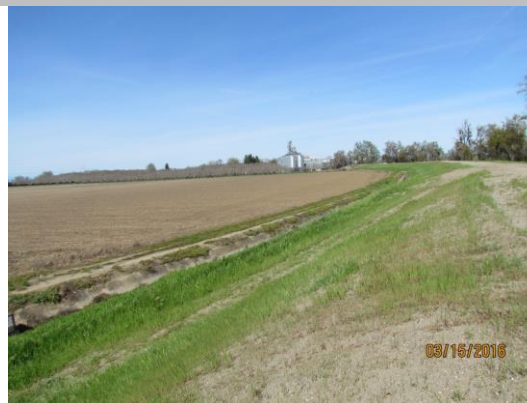
Photo 1 of 1 : SP_2016_NA0016_435_15_20160322_00239.jpg

LM Start	18.20	Rating **	M	Issue No.	15
LM End	18.46	Issue Type +	En	Location *	LS
Category	Earthen Levee			GPS Latitude/Longitude	
				Start	End
Item	Encroachments			38.946674 °	38.950263 °
				-121.837528 °	-121.837768 °
DWR ID	DWR_NA0016_01_s_2012_15				
Comment Code					
DT : Ditch					
Inspector Comment					
Concrete lined ditch runs along the toe of the levee.

View of the ditch on the landward side of the levee looking upstream.
Spring 2016.

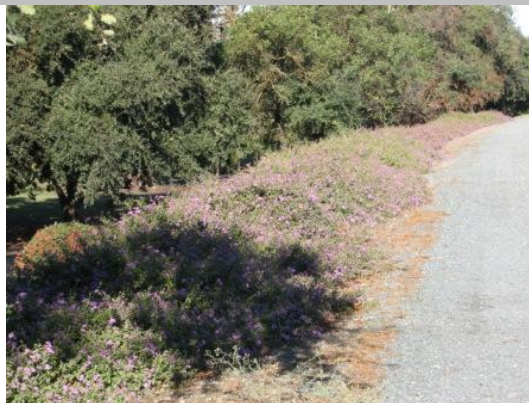
Photo 1 of 1 : SP_2016_NA0016_435_18_20160304_00018.jpg

LM Start	18.54	Rating **	M	Issue No.	18
LM End	18.54	Issue Type +	En	Location *	LS
Category	Earthen Levee			GPS Latitude/Longitude	
				Start	End
Item	Vegetation			38.951464 °	38.951464 °
				-121.838293 °	-121.838293 °
DWR ID	DWR_NA0016_01_s _ 2012_18				
Comment Code					
V6 : Landscaping					
Inspector Comment

Groundcover and trees with irrigation are planted on the levee slope. Fall 2011.

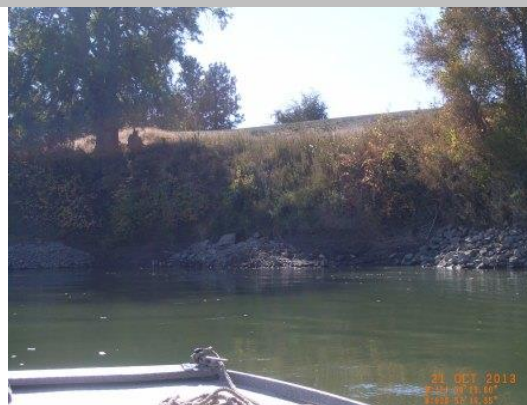
Photo 1 of 1 : SP_2016_NA0016_435_10_20160304_00010.jpg

LM Start	18.76	Rating **	M	Issue No.	10
LM End	18.78	Issue Type +	Ma	Location *	WS
Category	Supplemental			GPS Latitude/Longitude	
				Start	End
Item	2015 USACE Erosion Survey, DRAFT			38.954060 °	38.954312 °
				-121.840560 °	-121.840774 °
DWR ID	DWR_NA0016_01_s_2016_10				
Comment Code					
Inspector Comment					
2009 - Minor erosion, should be repaired under maintenance. 2011 - Some new minor erosion at the toe. 2015: No observed changes. [2015 Site ID: SAC_111-0_R]

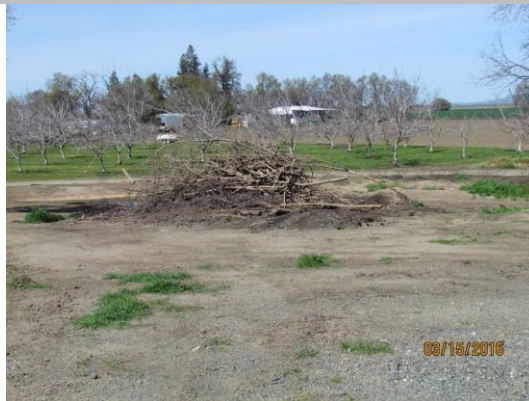
Photo 1 of 1 : SP_2016_NA0016_435_95_20160322_00243.jpg

LM Start	19.10	Rating **	M	Issue No.	95
LM End	19.10	Issue Type +	En	Location *	LS
Category	Earthen Levee			GPS Latitude/Longitude	
				Start	End
Item	Encroachments			38.957021 °	38.957021 °
				-121.837812 °	-121.837812 °
DWR ID	DWR_NA0016_01_s_2015_95				
Comment Code					
GA : Garbage					
Inspector Comment

View of the debris pile on the landward side of the levee. Spring 2016.

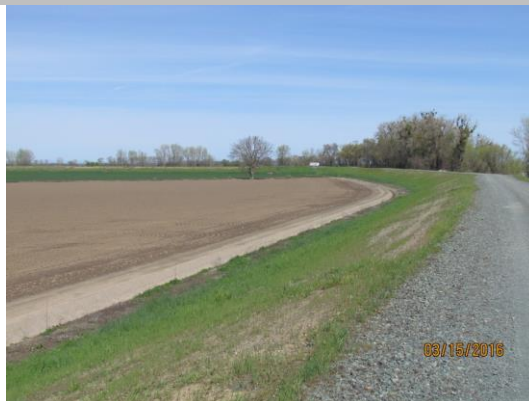
Photo 1 of 2 : SP_2016_NA0016_435_31_20160323_00246.jpg

LM Start	19.15	Rating **	M	Issue No.	31
LM End	19.61	Issue Type +	En	Location *	LS
Category	Earthen Levee			GPS Latitude/Longitude	
				Start	End
Item	Encroachments			38.957405 °	38.962648 °
				-121.836965 °	-121.834368 °
DWR ID	DWR_NA0016_01_s _ 2012_31				
Comment Code					
DT : Ditch					
Inspector Comment					
Concrete lined ditch up to LM 19.40. Soil ditch continues on until LM 19.61.

View of the ditch on the landward side of the levee looking upstream. Spring 2016.

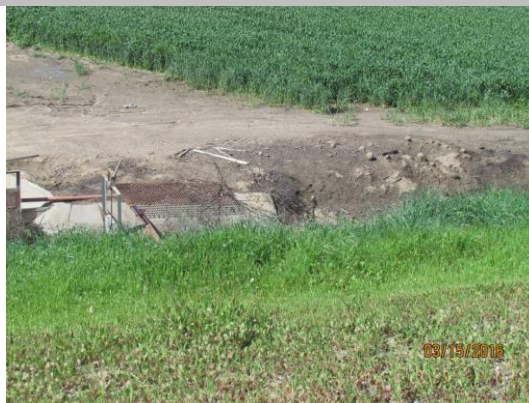
Photo 2 of 2 : SP_2016_NA0016_435_31_20160323_00245.jpg

Concrete lined ditch stops at levee mile 19.40.

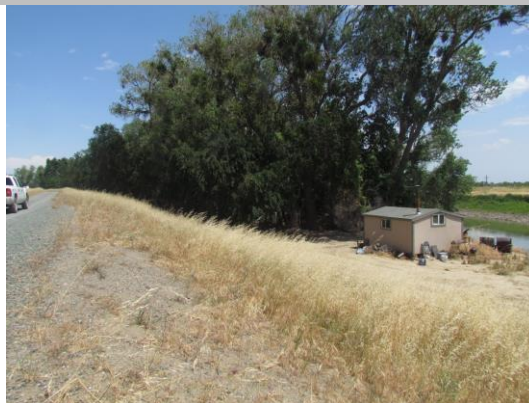
Photo 1 of 1 : SP_2016_NA0016_435_96_20160304_00048.jpg

LM Start	19.37	Rating **	M	Issue No.	96
LM End	19.37	Issue Type +	En	Location *	WS
Category	Earthen Levee			GPS Latitude/Longitude	
				Start	End
Item	Encroachments			38.959642 °	38.959642 °
				-121.834004 °	-121.834004 °
DWR ID	DWR_NA0016_01_s _ 2015_96				
Comment Code					
BU : Building					
Inspector Comment

View of the building on the waterward side of the levee looking upstream. Spring 2015.

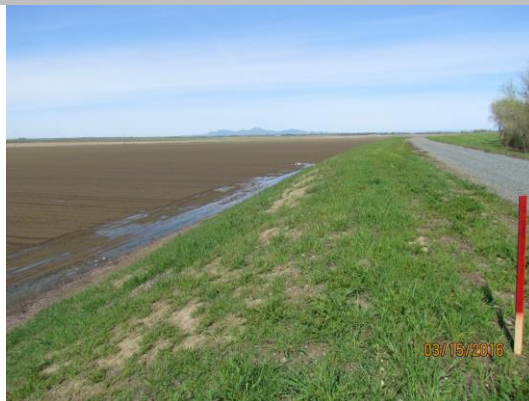
Photo 1 of 2 : SP_2016_NA0016_435_176_20160323_00247.jpg

LM Start	20.07	Rating **	U	Issue No.	176
LM End	20.21	Issue Type +	Ob	Location *	LS
Category	Earthen Levee			GPS Latitude/Longitude	
				Start	End
Item	Seepage / Sandboils			38.968952 °	38.970733 °
				-121.835239 °	-121.833896 °
DWR ID	DWR_NA0016_01_s _ 2016_176				
Comment Code					
Inspector Comment					
Seepage area has been staked and noted by LMA. Monitor seepage site.

View of the seepage on the landward side of the levee looking upstream. Spring 2016.

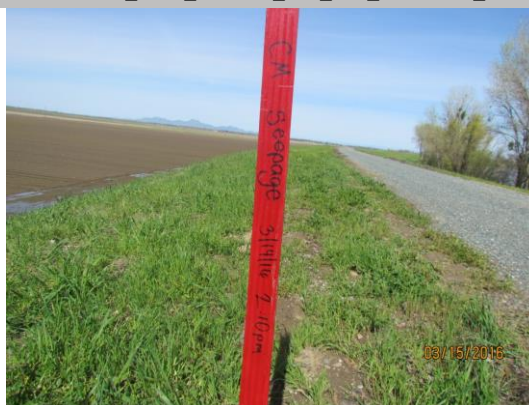
Photo 2 of 2 : SP_2016_NA0016_435_176_20160323_00248.jpg

Monitoring stake for the seepage. Spring 2016.

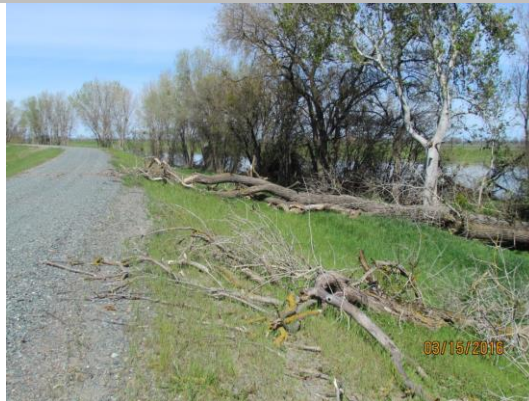
Photo 1 of 1 : SP_2016_NA0016_435_177_20160323_00249.jpg

LM Start	20.98	Rating **	M	Issue No.	177
LM End	20.98	Issue Type +	Ma	Location *	WS
Category	Earthen Levee			GPS Latitude/Longitude	
				Start	End
Item	Encroachments			38.975669 °	38.975669 °
				-121.821746 °	-121.821746 °
DWR ID	DWR_NA0016_01_s _ 2016_177				
Comment Code					
TR : Tree or limb					
Inspector Comment

View of the fallen tree on the waterward side of the levee looking upstream. Spring 2016.

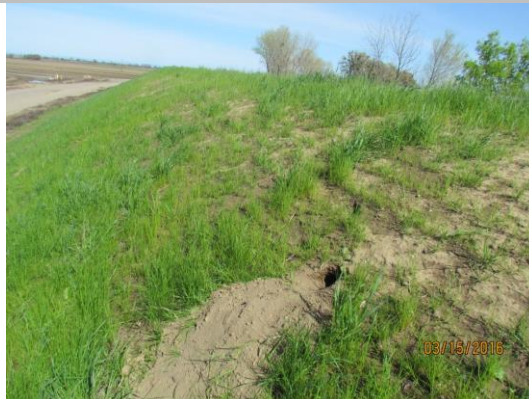
Photo 1 of 1 : SP_2016_NA0016_435_179_20160323_00250.jpg

LM Start	21.89	Rating **	M	Issue No.	179
LM End	21.89	Issue Type +	Ma	Location *	LS
Category	Earthen Levee			GPS Latitude/Longitude	
				Start	End
Item	Animal Control			38.988449 °	38.988449 °
				-121.820009 °	-121.820009 °
DWR ID	DWR_NA0016_01_s _ 2016_179				
Comment Code					
A3 : No rodents visible, but rodent burrows visible; need to backfill and compact or grout burrows.					
Inspector Comment

View of the rodent hole on the landward side of the levee looking upstream. Spring 2016.

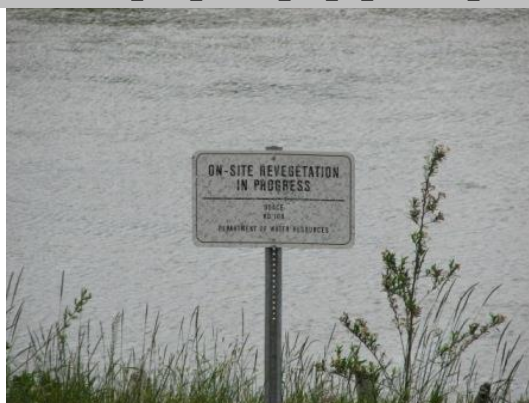
Photo 1 of 2 : SP_2016_NA0016_435_30_20160304_00025.jpg

LM Start	22.12	Rating **	A/W	Issue No.	30
LM End	22.42	Issue Type +	Ob	Location *	WS
Category	Earthen Levee			GPS Latitude/Longitude	
				Start	End
Item	Vegetation			38.989528 °	38.989722 °
				-121.816020 °	-121.810488 °
DWR ID	DWR_NA0016_01_s _ 2012_30				
Comment Code					
V8 : Environmental Requirements.					
Inspector Comment

Revegetation site. Photo taken spring 2012.

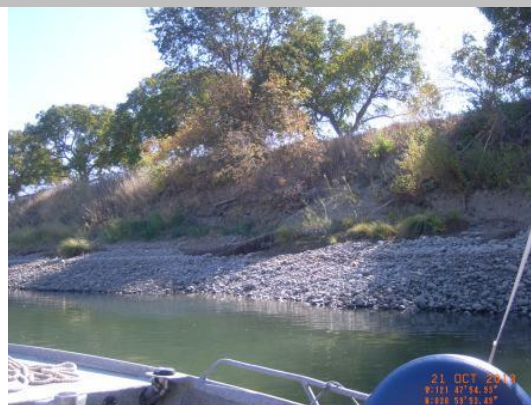
Photo 1 of 1 : SP_2016_NA0016_435_11_20160304_00011.jpg

LM Start	23.55	Rating **	M	Issue No.	11
LM End	23.65	Issue Type +	Ma	Location *	WS
Category	Supplemental			GPS Latitude/Longitude	
				Start	End
Item	2015 USACE Erosion Survey, DRAFT			38.997696 °	38.998336 °
				-121.797584 °	-121.799298 °
DWR ID	DWR_NA0016_01_s _ 2016_11				
Comment Code					
Inspector Comment					
2008 - Slippage of cobbles off hard underlying toe material. 2011 - Minor slumping site. 2012 - Failing cobble site, site extended upstream. 2015: No observed changes. [2015 Site ID: SAC_115-9_R]

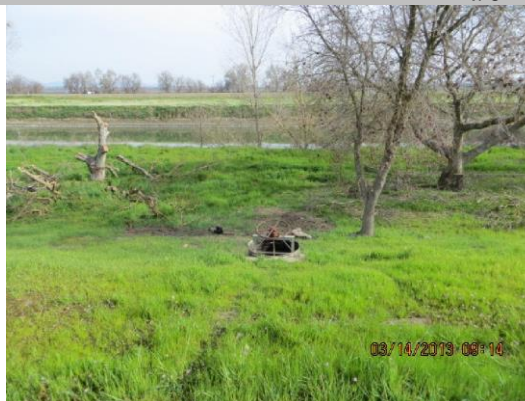
Photo 1 of 2 : UCIP_SP_2016_10261_17466.jpg

LM Start	23.70	Rating **	M	Issue No.	1570
LM End	23.70	Issue Type +	En	Location *	WS
Category	Supplemental			GPS Latitude/Longitude	
				Start	End
Item	DWR UCIP Field Study			38.998247 °	38.998247 °
				-121.800236 °	-121.800236 °
DWR ID					
Comment Code					
Inspector Comment					
FS_ID:10261 DS_ID:20249 EP_NO: 9374 Repair Type: Non-Urgent Crossing Status: Found UCIP Comments: Appears abandoned. Pipe should be properly abandoned. FIELD_STRUCT_DESC: 1 of 4: 36-inch corrugated metal pipe through levee 20.0 feet below crown. One corrugated metal cutoff wall installed by United States Army Corp of Engineers, 1955. Slide gate in 36-inch corrugated metal riser on the waterward slope. Pump on the waterward bank. Concrete standpipe at toe of the landward slope (ABO No. 9374, 1974). Originally included in the 1960 O&M manual. FS Date: 3/14/2013

36-inch cmp riser on WS slope with slide gate.
